# UNDERWATER BRIDGE INSPECTION REPORT

STRUCTURE NO. 63516

RED LAKE RIVER

DISTRICT 2 - RED LAKE COUNTY

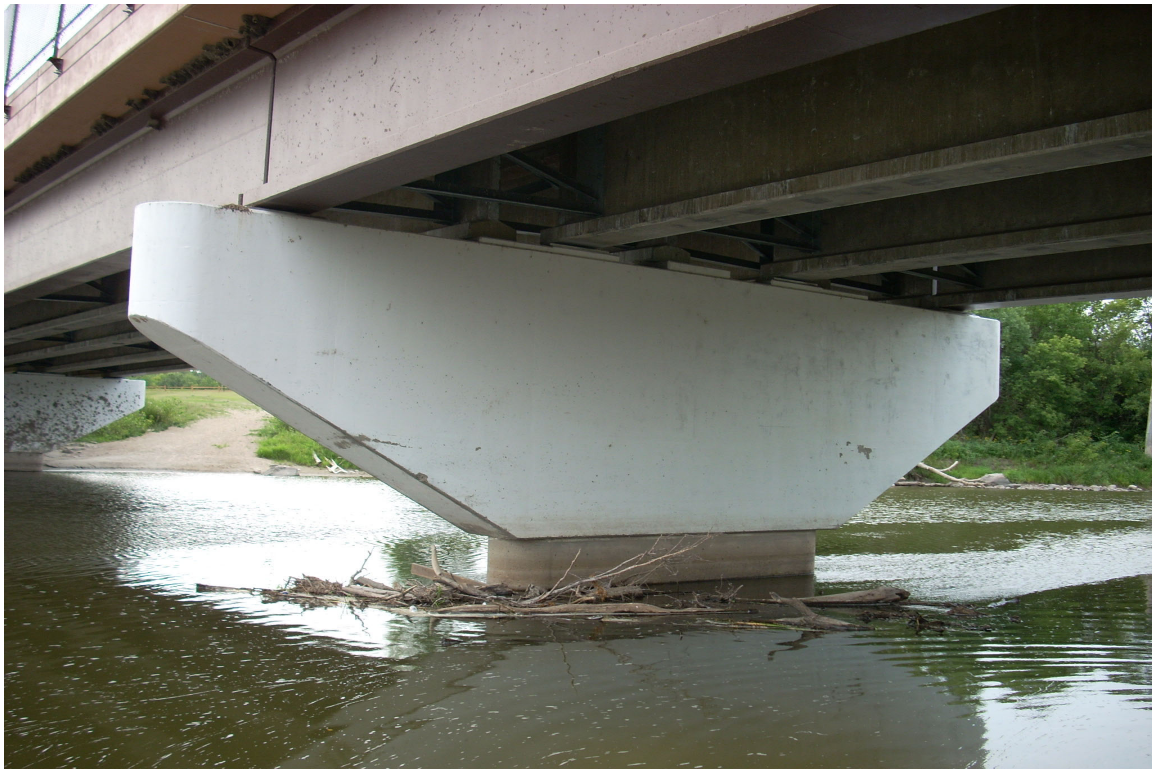
Photograph 2. View of Pier 1, Looking Southwest.

- (A) A heavy accumulation of 12-inch-diameter-and-smaller timber debris was observed at the upstream end of Pier 1 extending from the channel bottom to 3 feet above the waterline. The debris extended along the entire north face of the pier and extended from the pier to the shore.

- (A) Remove the timber debris at Pier 1 during routine maintenance to inhibit further accumulation and any adverse effects on pier or surrounding channel bottom.
- (B) Reinspect the submerged substructure units at the normal maximum recommended (NBIS) interval of five (5) years.

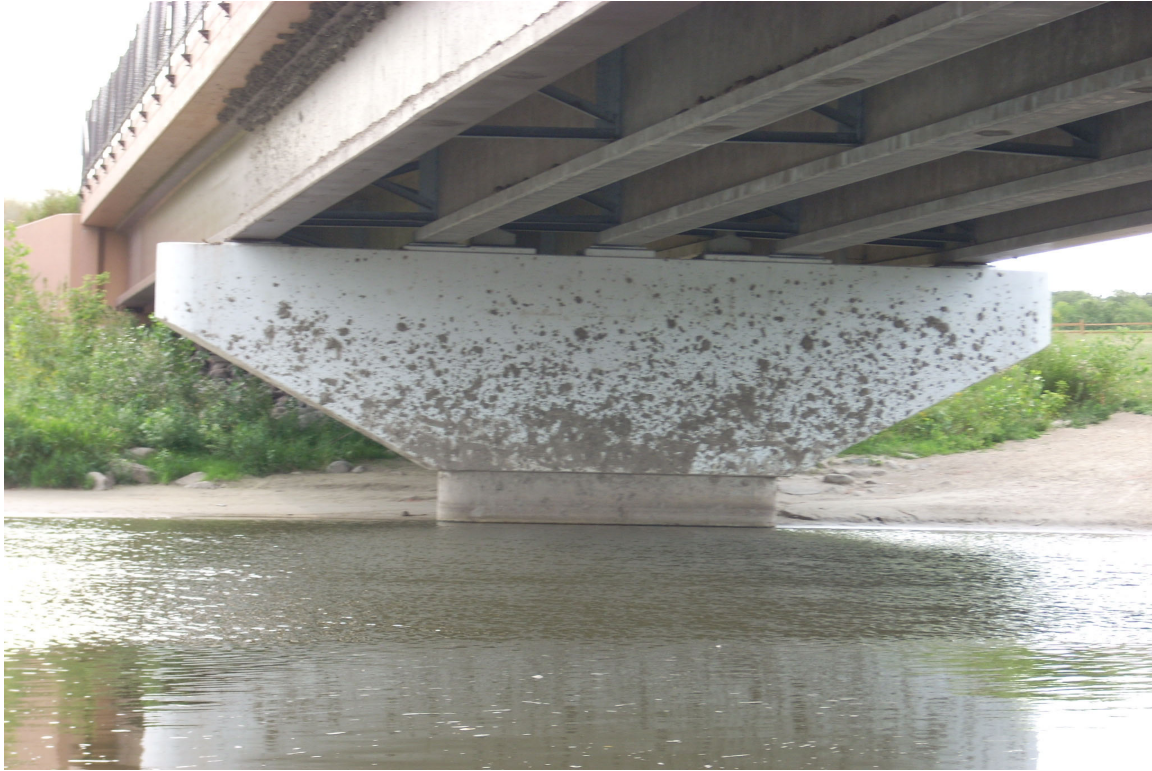
Photograph 3. View of Pier 2, Looking Southwest.

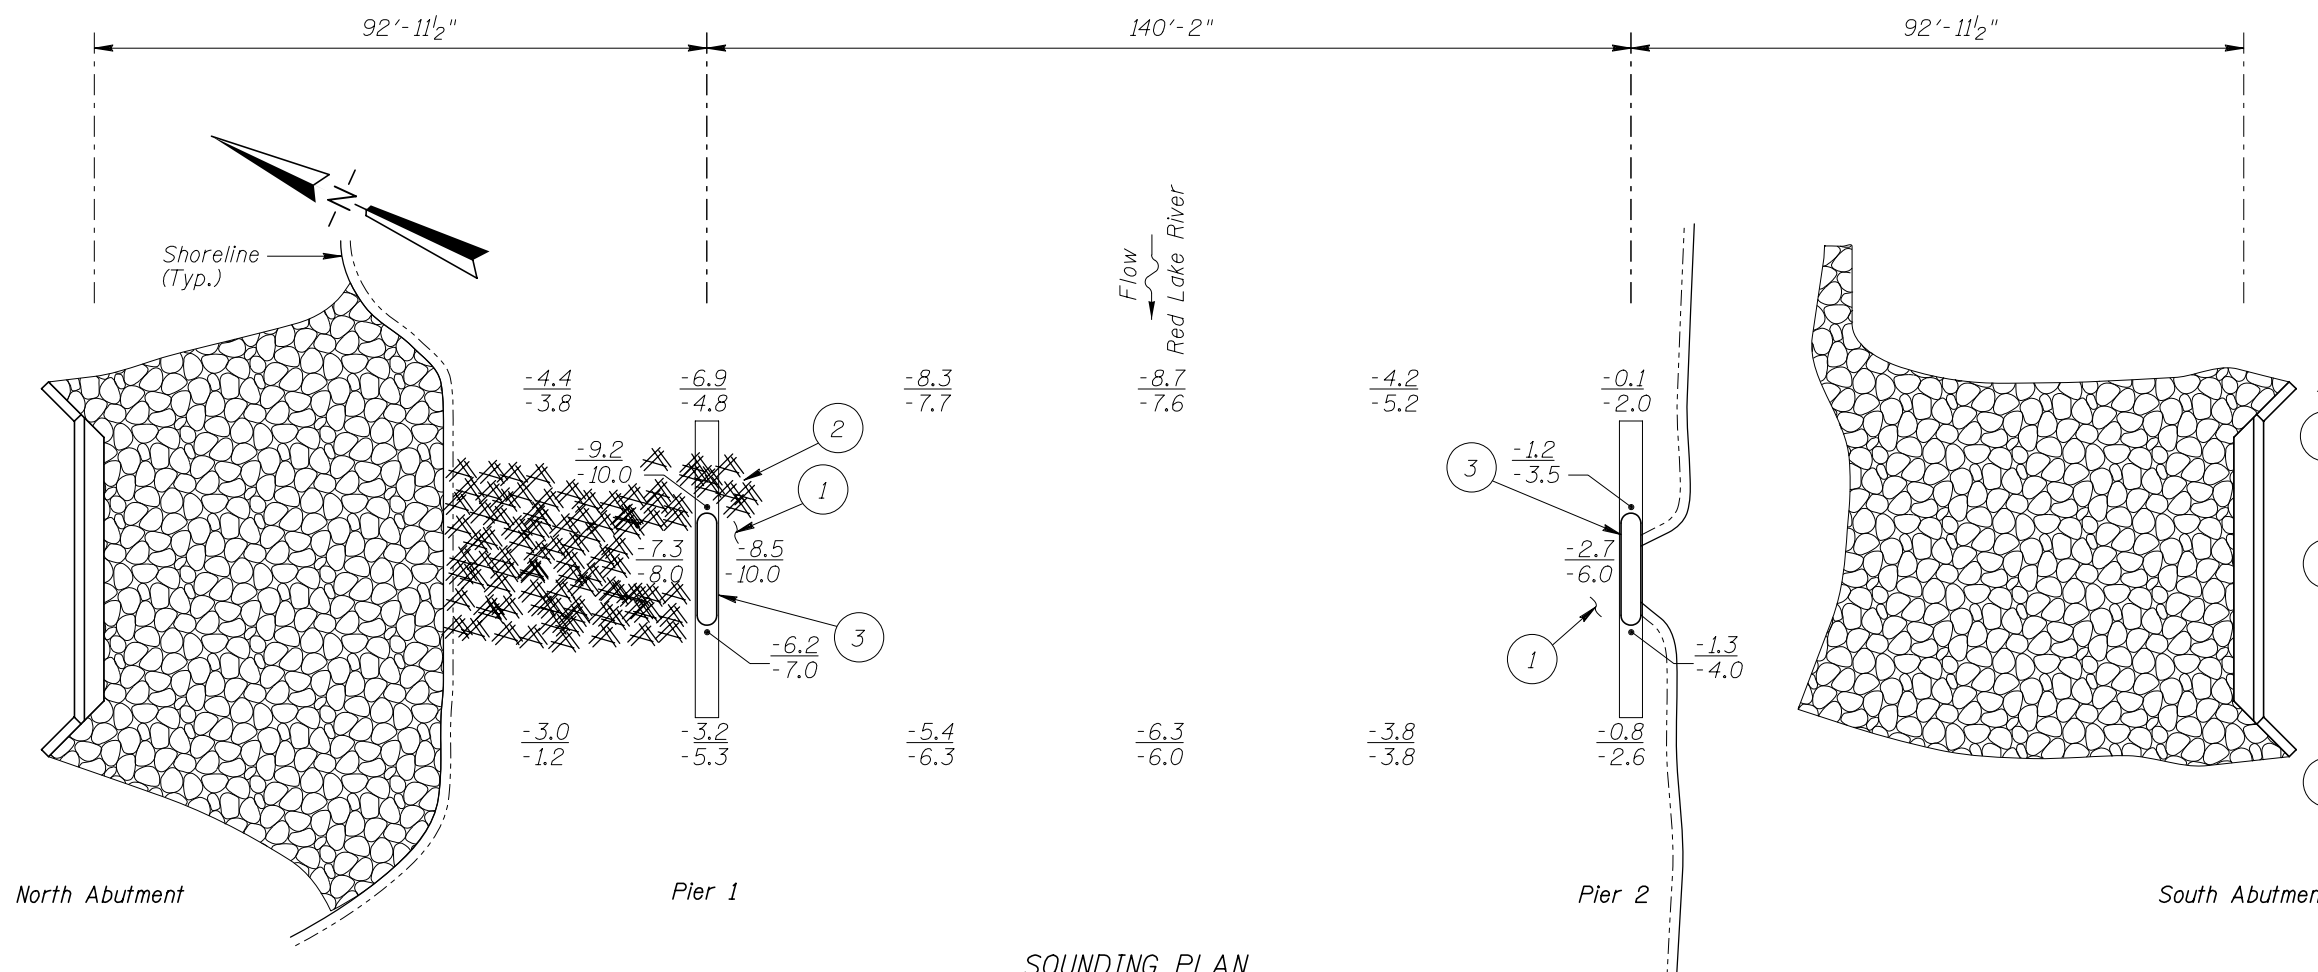
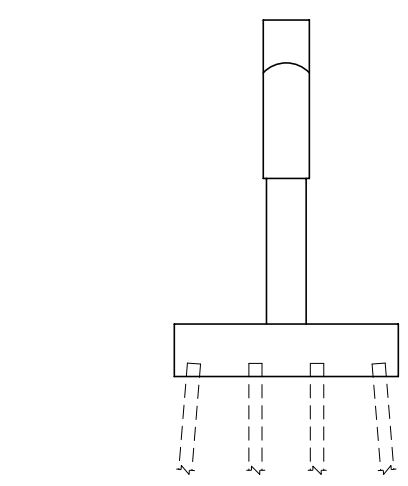
- INSPECTION NOTES:**
- 1 The channel bottom consisted of sandy silt and scattered riprap with 1 foot of probe rod penetration around the entire perimeter of both piers.
  - 2 A heavy accumulation of 12-inch-diameter and smaller timber debris consisting of logs and branches was observed at Pier 1, extending from the channel bottom to 3 feet above the waterline, radiating out up to 10 feet from the upstream nose, and along the entire north face extending to the north shoreline.
  - 3 The concrete above and below the waterline was typically smooth and sound with no defects of structural significance observed.

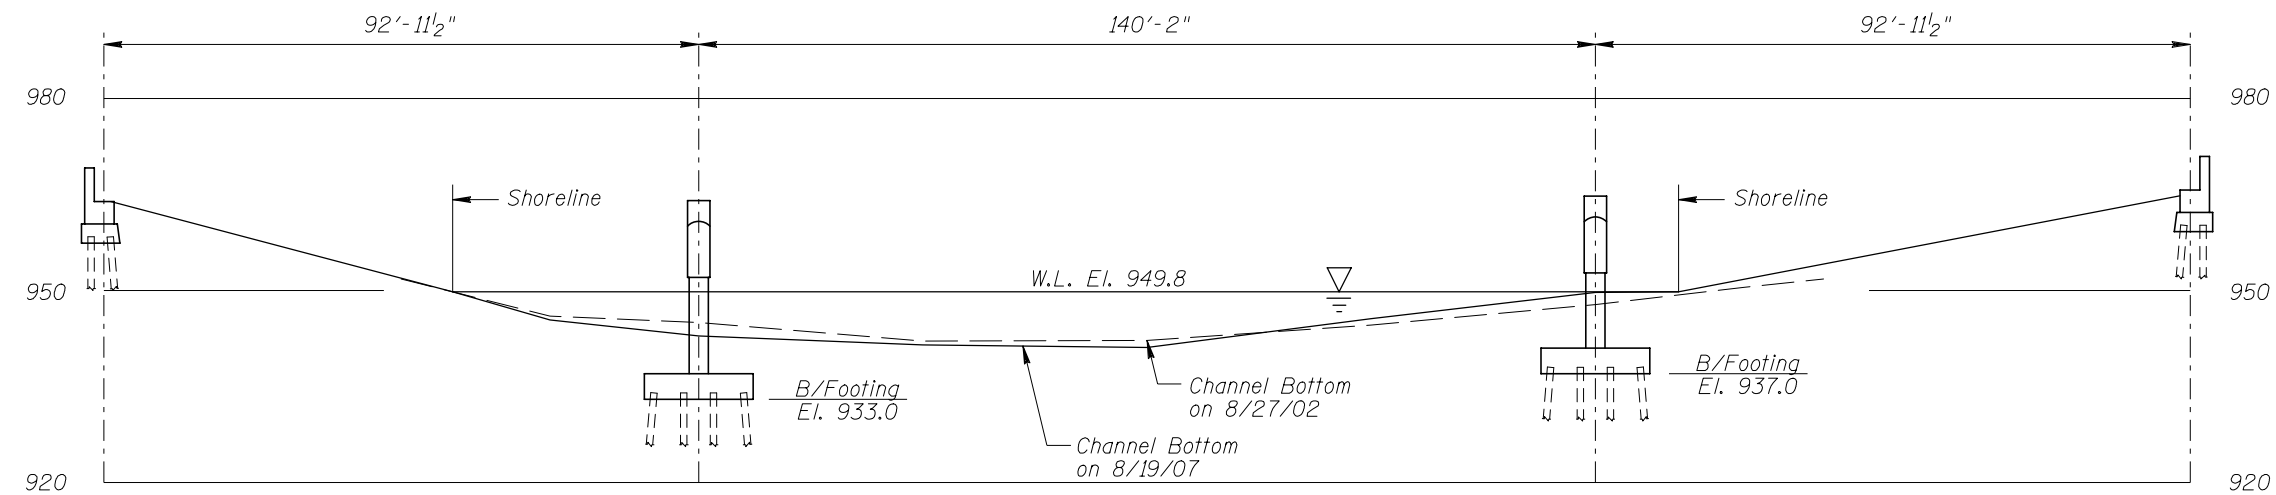
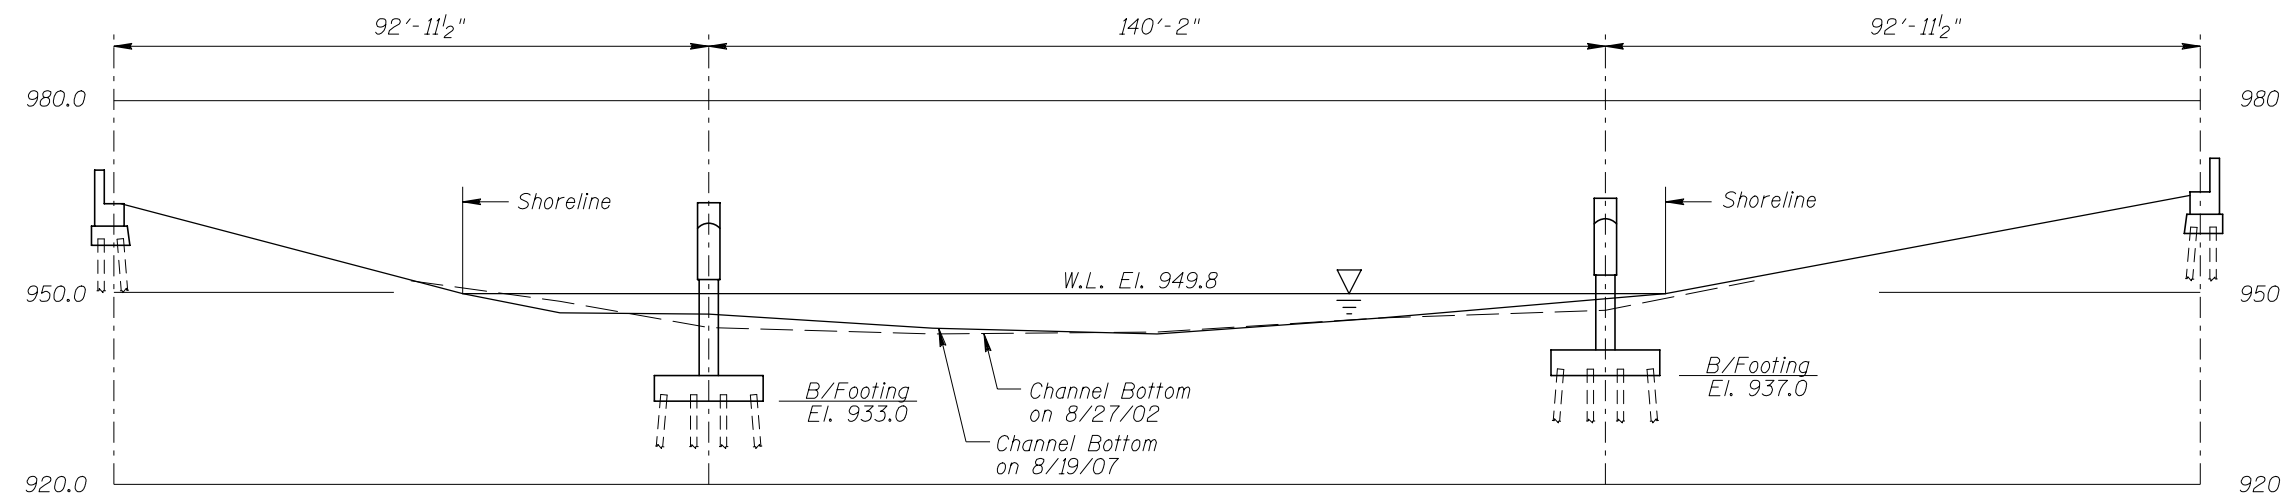
UPSTREAM FASCIA PROFILE

DOWNSTREAM FASCIA PROFILE
